PENNSYLVANIA
WADHAM CREEK DAM

NDI LD. No. PA-00547
PENNDER LD. No. 40-209

PHASE I INSPECTION REPORT
NATIONAL DAM INSPECTION PROGRAM

WADHAM CREEK DAM

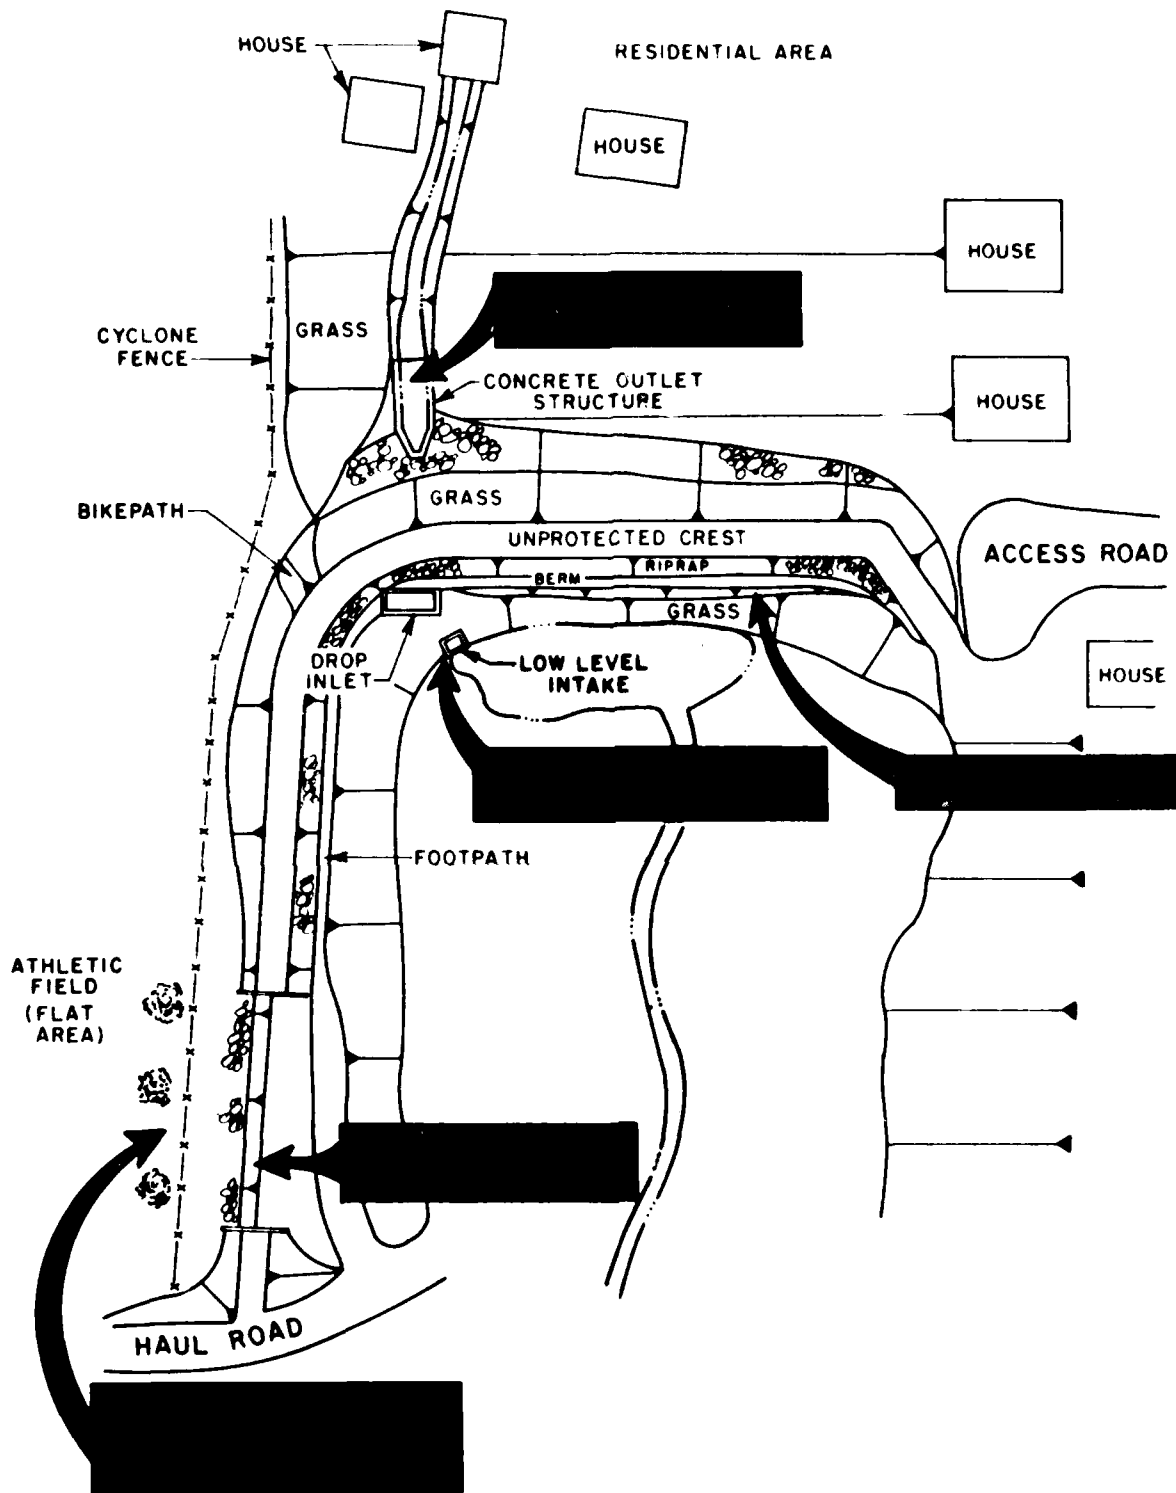
WADHAM CREEK DAM
GENERAL PLAN - FIELD INSPECTION NOTES

ITEM	OBSERVATIONS/REMARKS/RECOMMENDATIONS	NDI# PA - 00547
SURFACE CRACKS	None observed.	
UNUSUAL MOVEMENT OR CRACKING AT OR BEYOND THE TOE	None observed.	
SLOUGHING OR EROSION OF EMBANKMENT AND ABUTMENT SLOPES	Minor sloughing observed below the berm on the upstream embankment face to the right of the service spillway. Unprotected crest is utilized as a foot and bicycle path and, thus, has no grass cover. Bicycle path also at bend in embankment on downstream face.	
VERTICAL AND HORIZONTAL ALIGNMENT OF THE CREST	Horizontal - Good. Vertical - Good (see "Profile of Dam Crest", Appendix A).	
RIPRAP FAILURES	Portions of the riprap on both slopes have been displaced. This can be attributed to the fact that the facility is located within an urban area and is subject to casual vandalism and misuse by the local populace.	
JUNCTION OF EMBANKMENT AND ABUTMENT, SPILLWAY AND DAM	Good condition. Bicycle rut at right abutment-embankment junction. Gravel covered roadway and adjacent drainage ditch located at left abutment embankment junction.
